Cabot Oil & Gas Corporation

# DEP Meeting

October 11, 2011

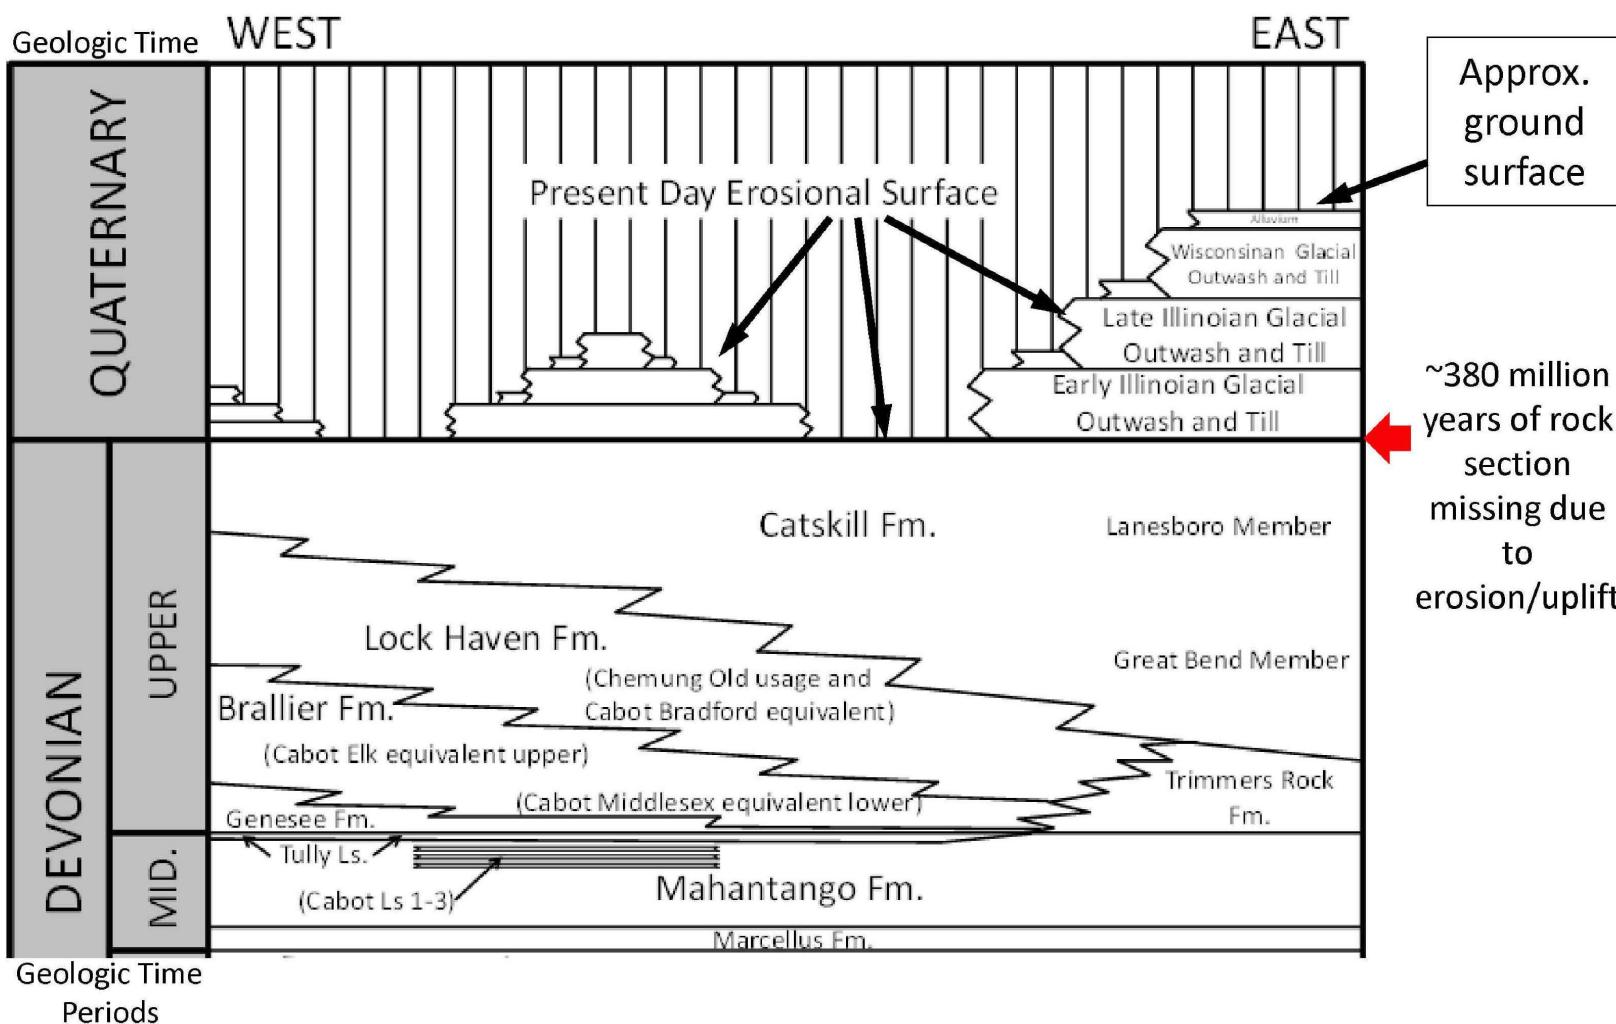
## Surface Geology and Shallow Stratigraphy – Susquehanna County Area

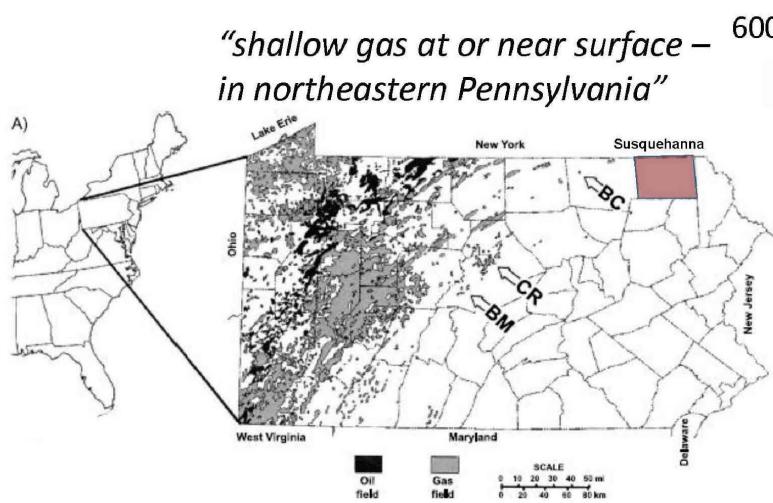
## Upper Devonian burial depths, gas generation, uplift

- Deposited ~380 My in marine and fluvial environments - sand, shales, organics
- Upper Devonian, Catskill Formation burial depths 5-6 km or 3-4 miles
- Deepest burial 290 to 270 My, placing organics in these rocks in the gas window
- Roughly 98% of any oil remaining at this time was cracked to gas
- Gas expelled from the Upper Devonian source rocks migrated and accumulated in the sandstones of the Catskill and Lock Haven Formations from about 270 to 240 My during deepest burial and initial uplift
- Successive uplift, orogenic events and glaciation removed the younger overburden exposing the Upper Devonian rocks at the surface in Susquehanna County and northeast Pennsylvania or **exhumed this giant gas reservoir**

(Modified from Laughrey et al., 2004, Fig. 1A and 15)  
BC Brace Creek; CR Council Run Field; BR Black Moshannon; Oil and gas fields .

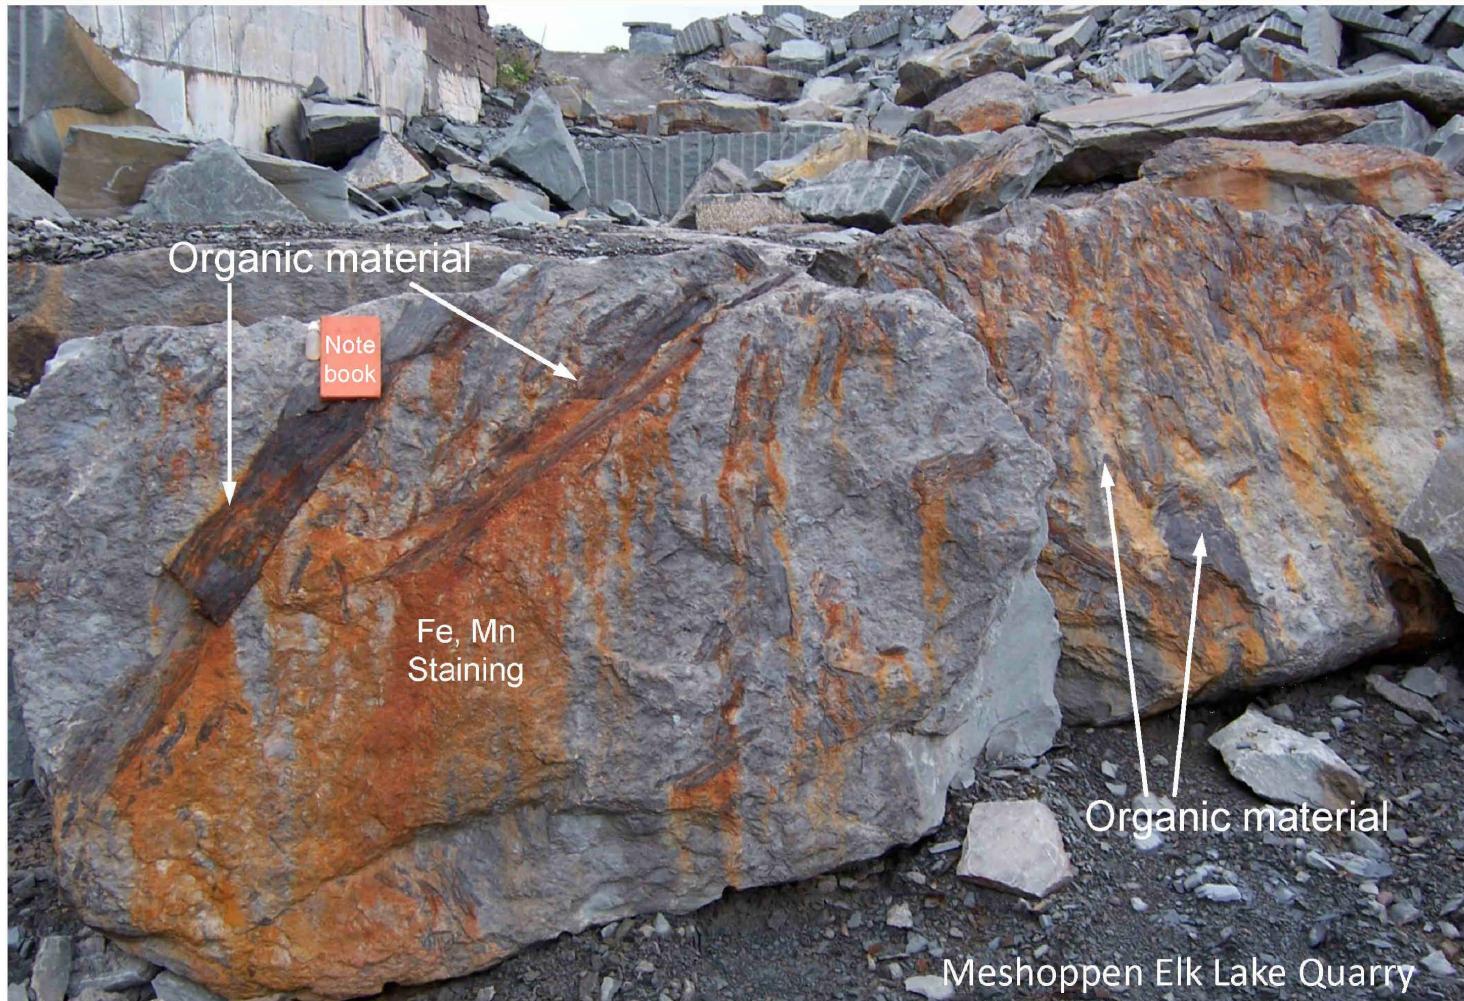
## Upper Devonian Organic Material abundant and source of Stray Gas

**Water wells and gas wells penetrate this organic material and encounter associated stray gas found in the sandstones and siltstones of the Catskill Formation in Susquehanna County**

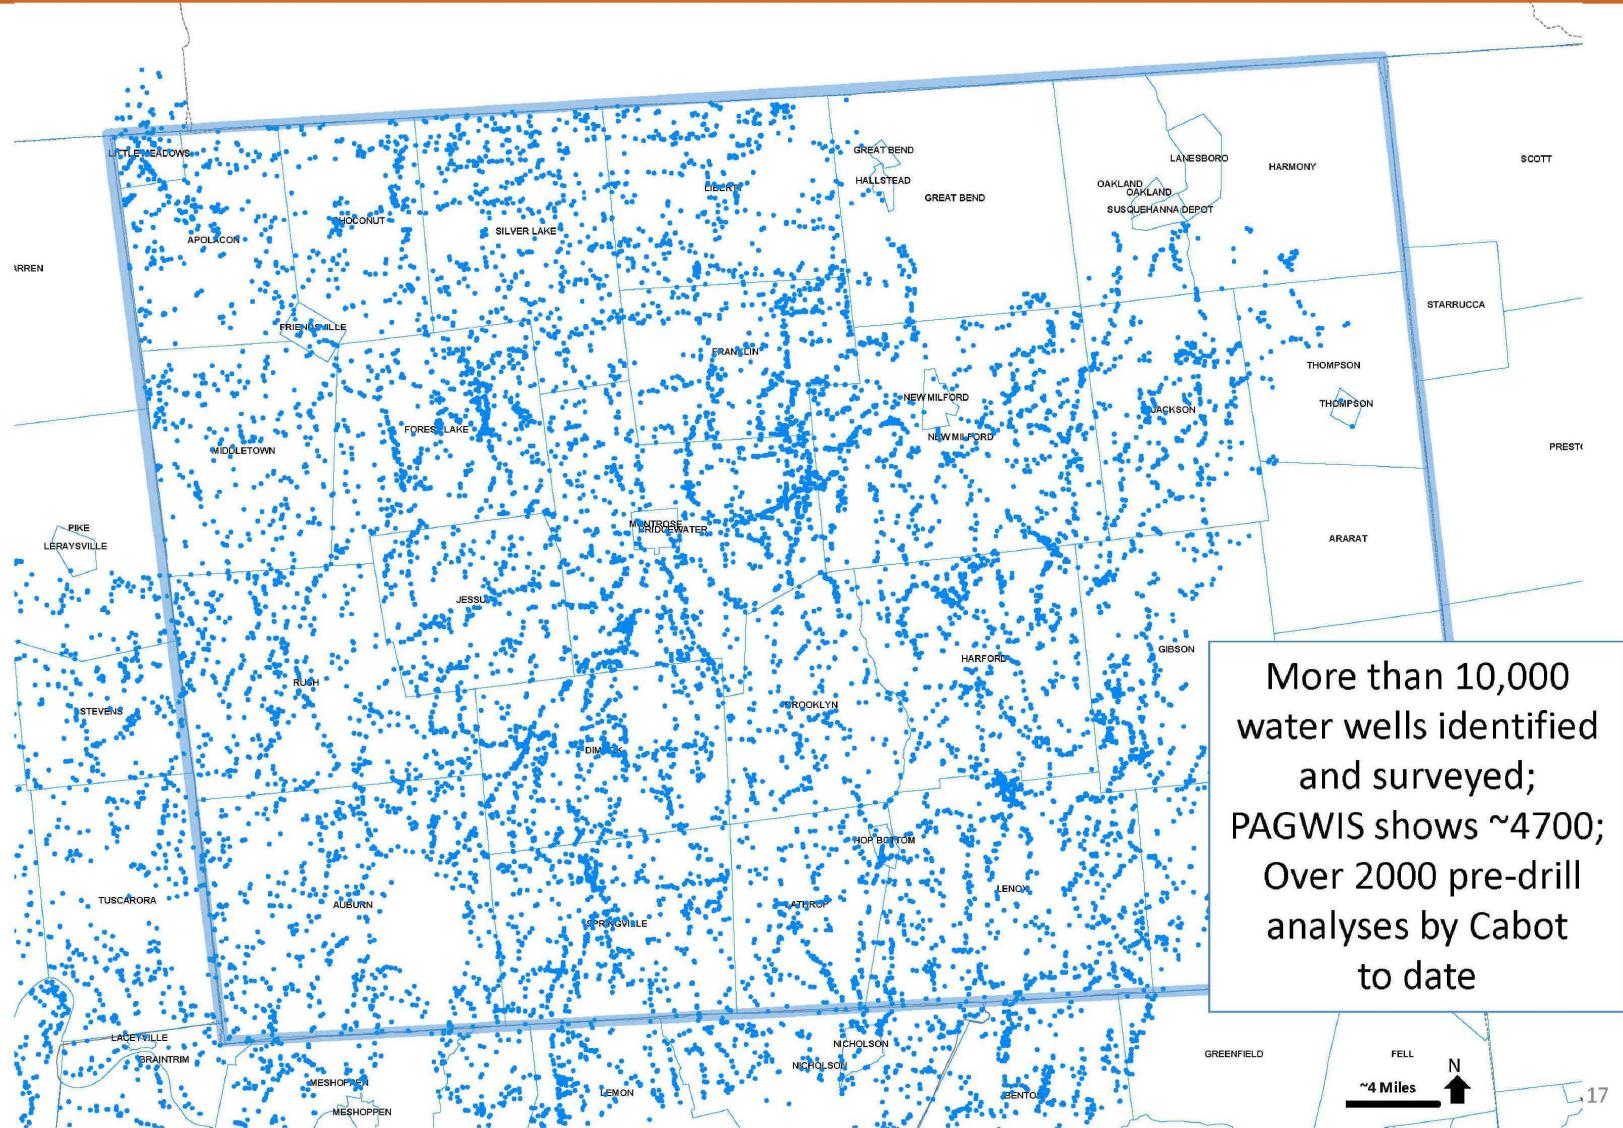
## Water Wells Identified - Susquehanna County

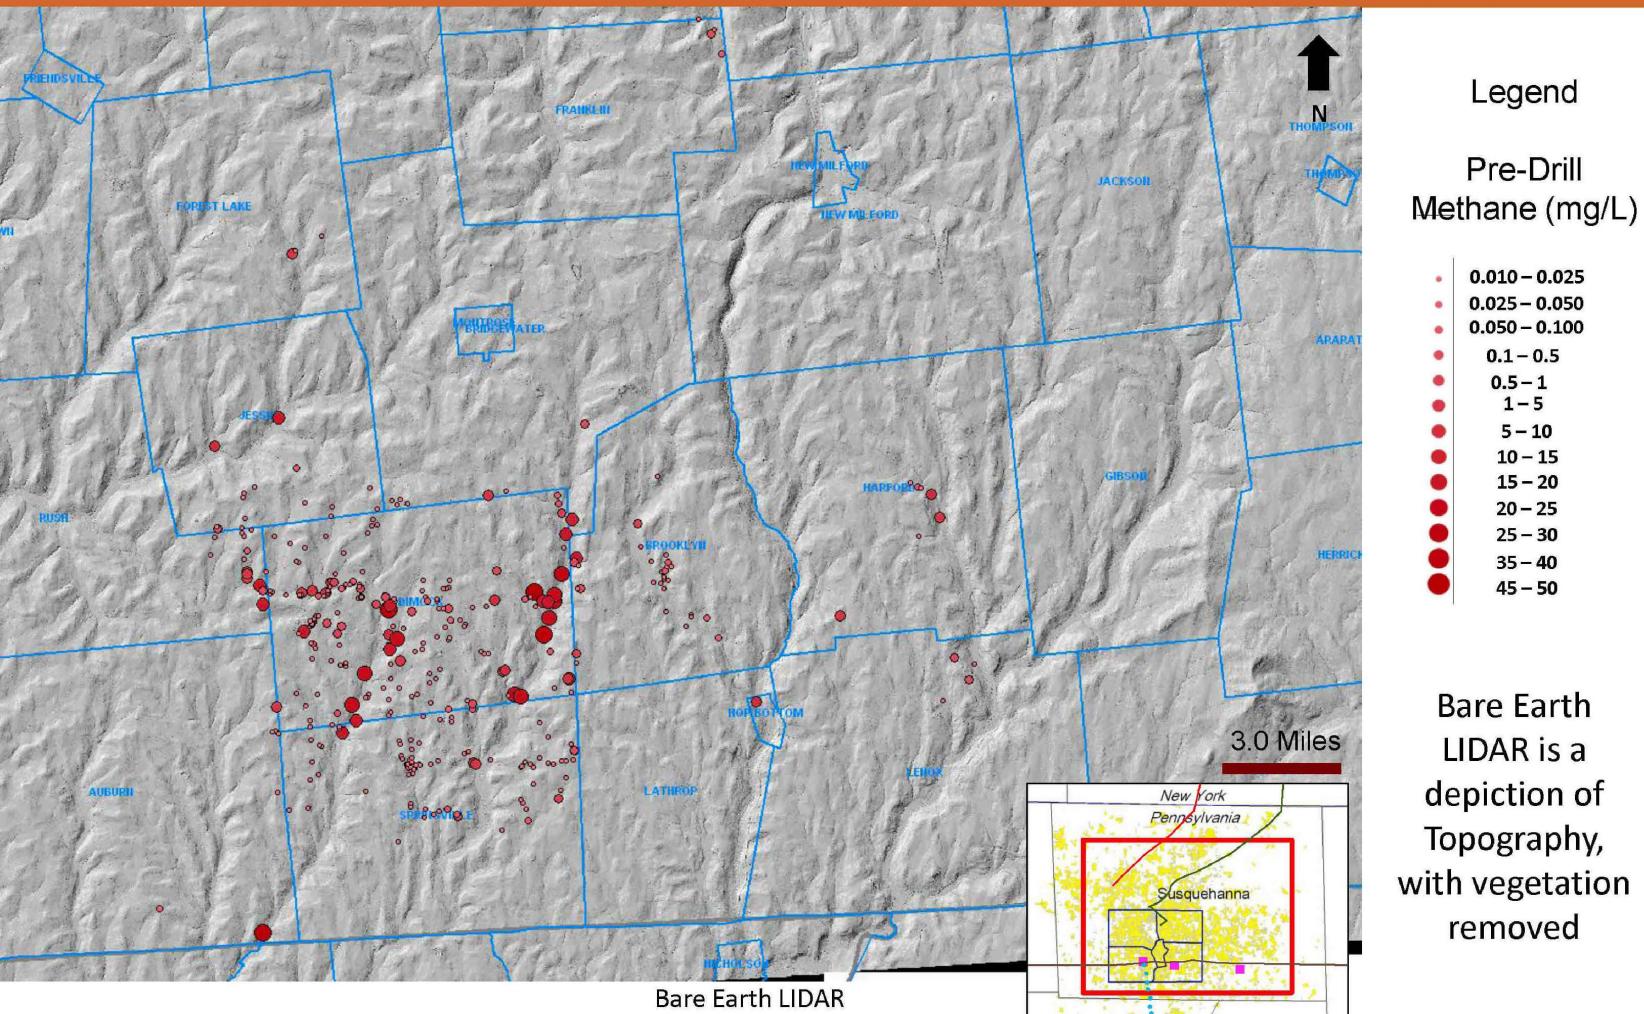
## Pre-Drill Methane Susquehanna County, PA - 2010

Observation: “prevalence of higher stray methane in valleys”

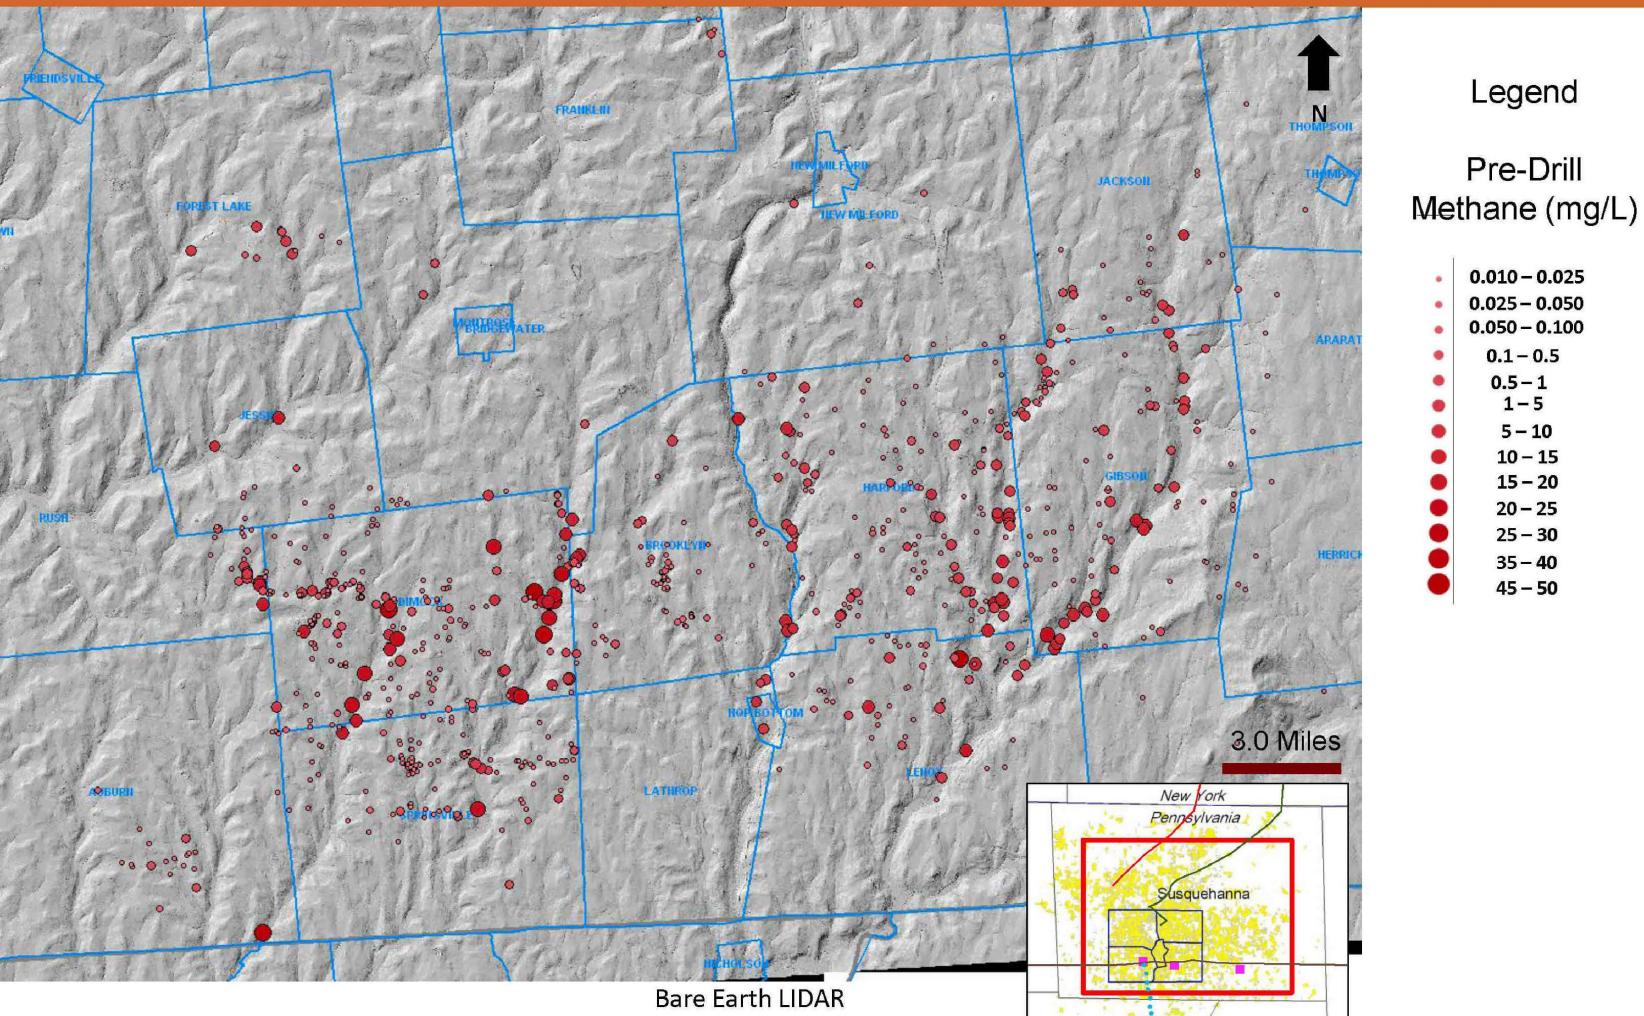
## Pre-Drill Methane Susquehanna County, PA – cont'd

Upper Devonian rocks charged with stray methane at or near surface – this is background.

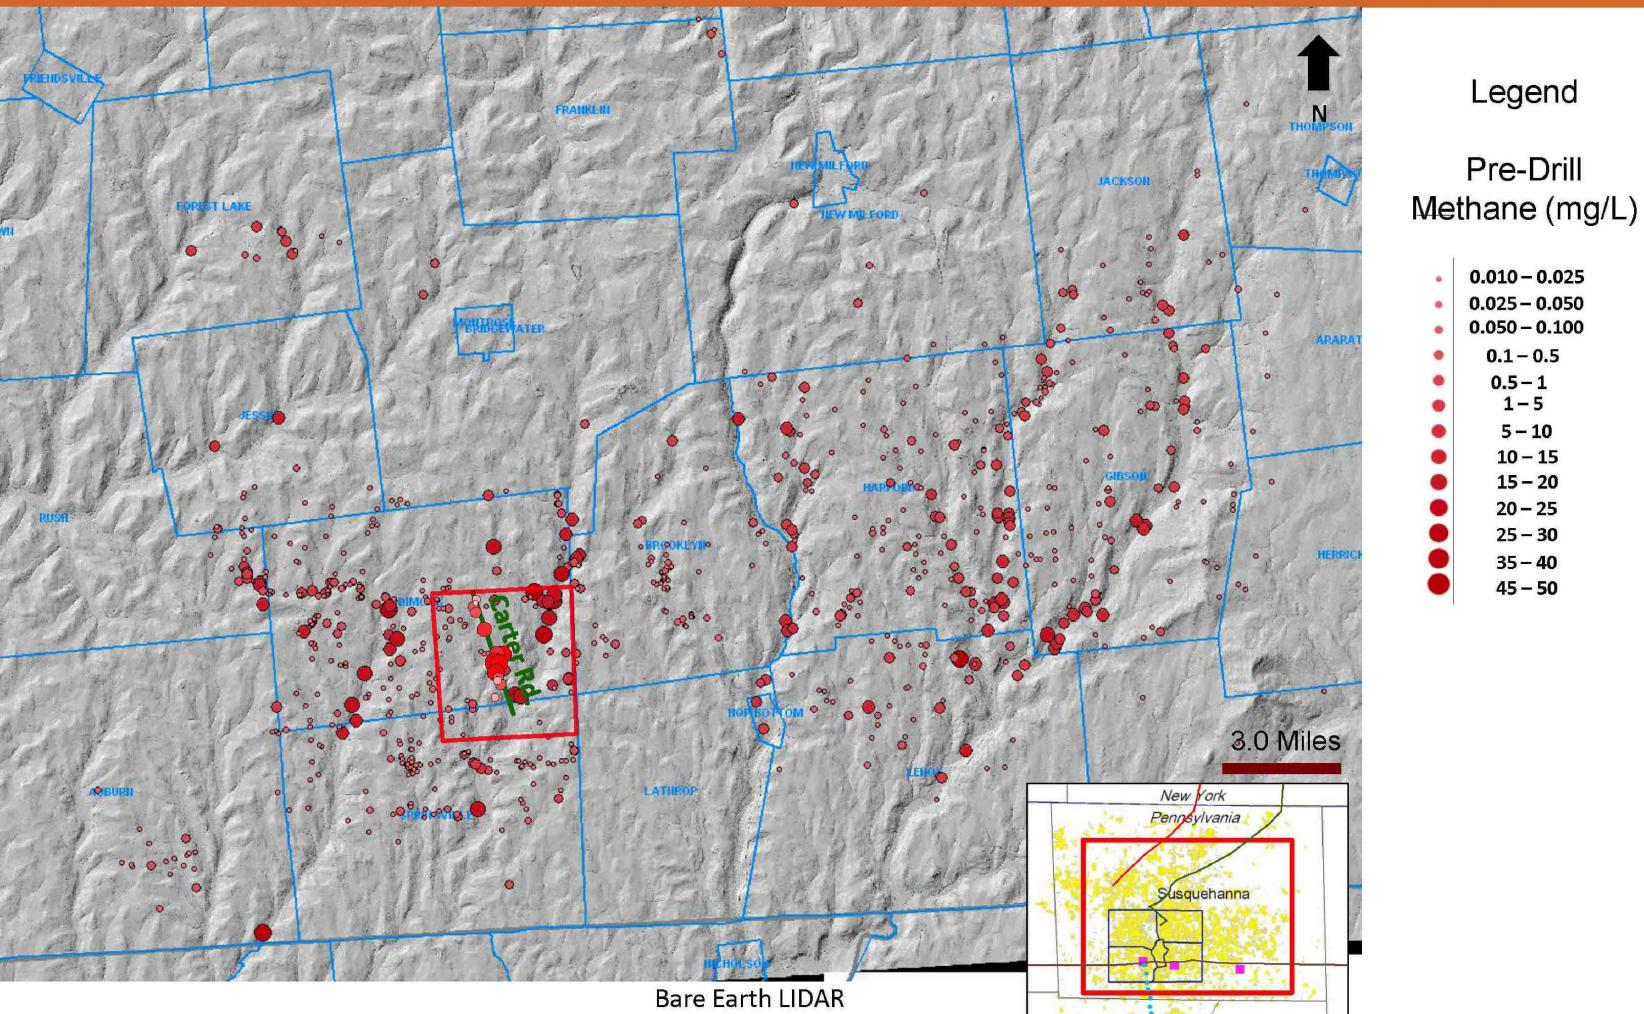
## Pre-Drill Methane Susquehanna County, PA – cont'd

Upper Devonian rocks charged with stray methane at or near surface – this is background.

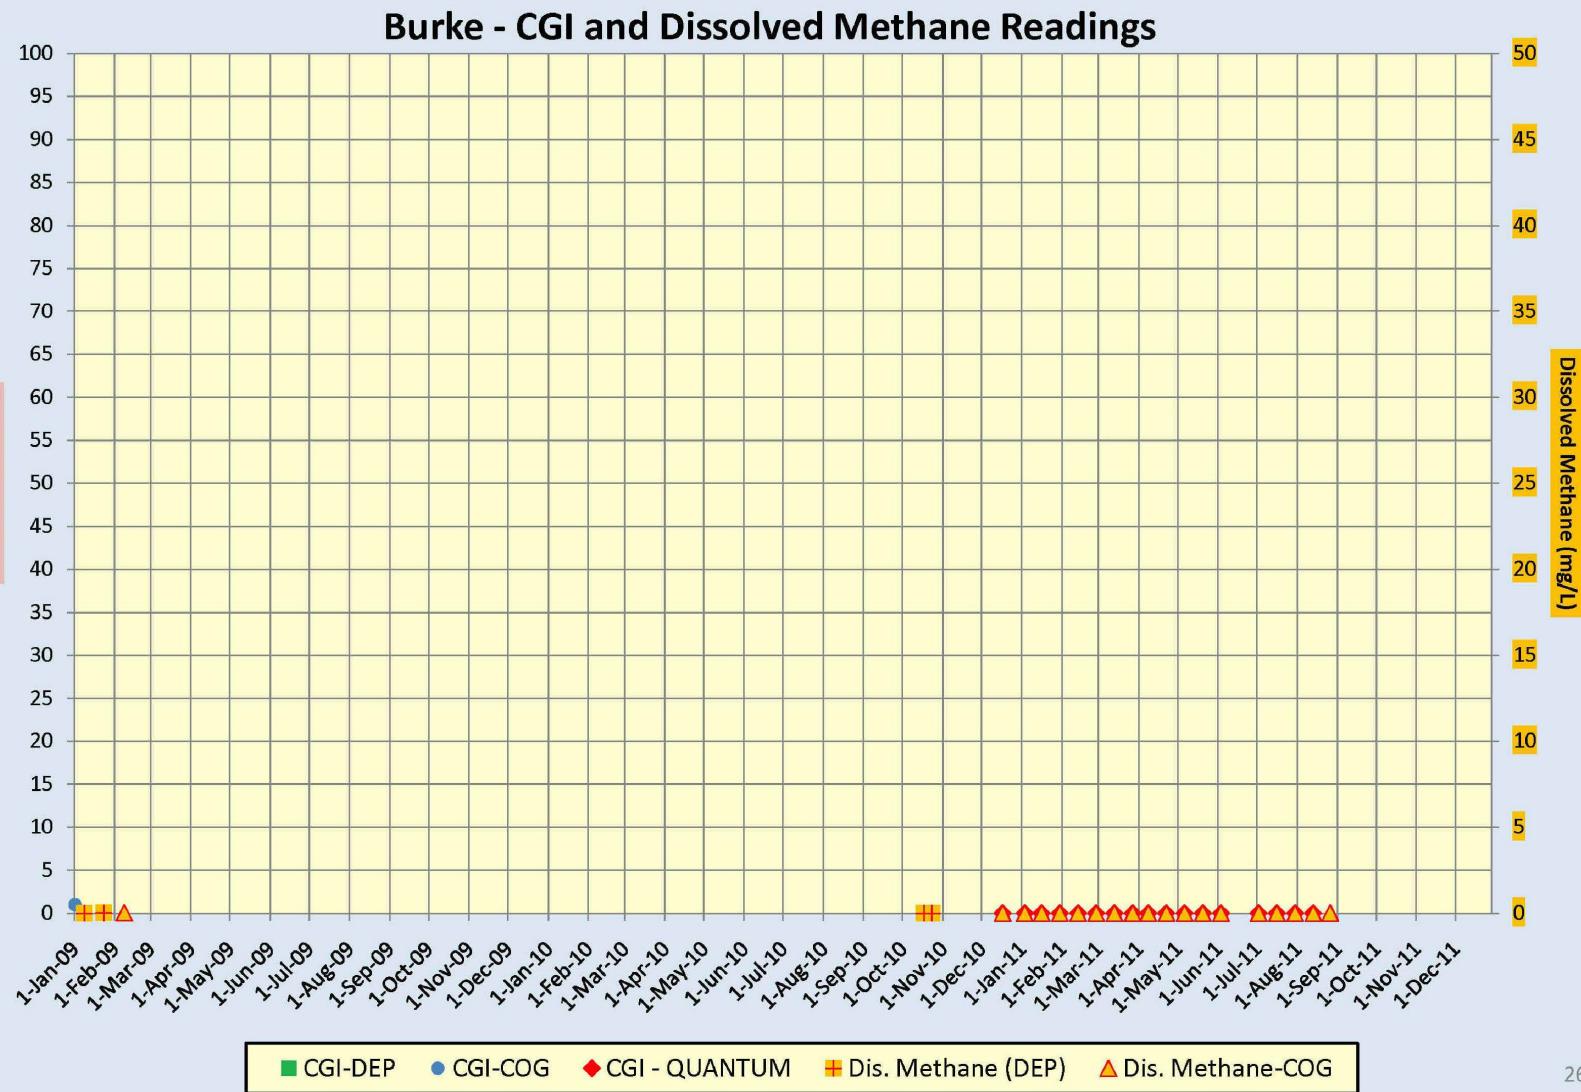
# Burke, Ed and Becky – CGI and Dissolved Methane Graphs

<b>Water Well - Owner</b>	Ed and Becky Burke	
<b>Exceed Primary:</b>	Total and Fecal Coliform	
<b>Exceed Secondary:</b>	pH	
<b>Dissolved Gas:</b>	Most Recent Result = 0.014 mg/L (8/31/2011)	
Before Treatment:	Baker 1V - P&A	Hubbard 5H
After Treatment:	Baker 3H	Hubbard 6H
	Hubbard 1V	
<b>Gas Wells ≤ 1000':</b>	None	
<b>Gas Wells 1000' - 2500':</b>	Baker 1V - P&A Baker 3H Hubbard 1V	Hubbard 5H Hubbard 6H
<b>Plan Forward:</b>	Continue to monitor as per CO&SA.	
<b>Comments:</b>	Received escrow funds. Installed treatment system.

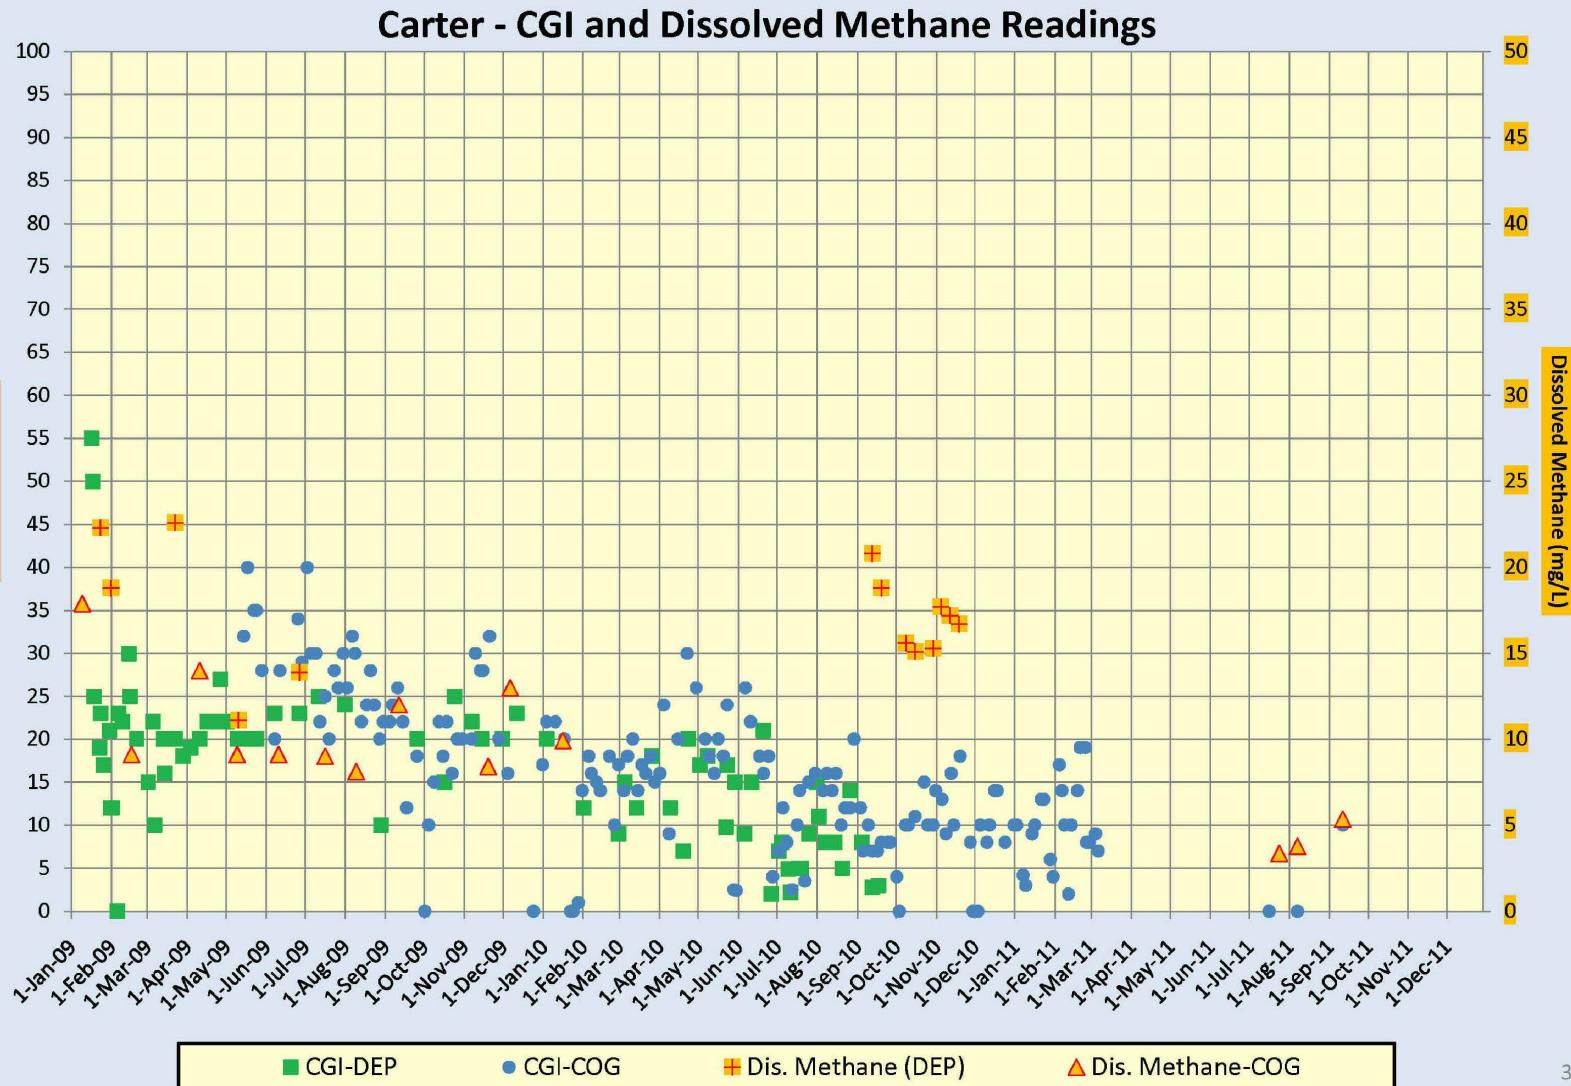
## Carter – CGI and Dissolved Methane Graphs

<b>Water Well - Owner</b>	Ron Sr. and Jean Carter	
<b>Exceed Primary:</b>	None	
<b>Exceed Secondary:</b>	Aluminum pH	
<b>Dissolved Gas:</b>	Most Recent Result = 5.35 mg/L (9/15/2011)	
Before Treatment:	N/A	
After Treatment:	N/A	
<b>Gas Wells ≤ 1000':</b>	Gesford 2V Gesford 7H	
<b>Gas Wells 1000' - 2500':</b>	Gesford 1V Gesford 5H Baker 3H Baker 1V - P&A	Gesford 3 – P&A Gesford 9 – P&A
<b>Plan Forward:</b>	Continue to monitor as per CO&SA. Offer treatment system.	
<b>Comments:</b>	Receiving bottled and bulk water. Refusing treatment system.

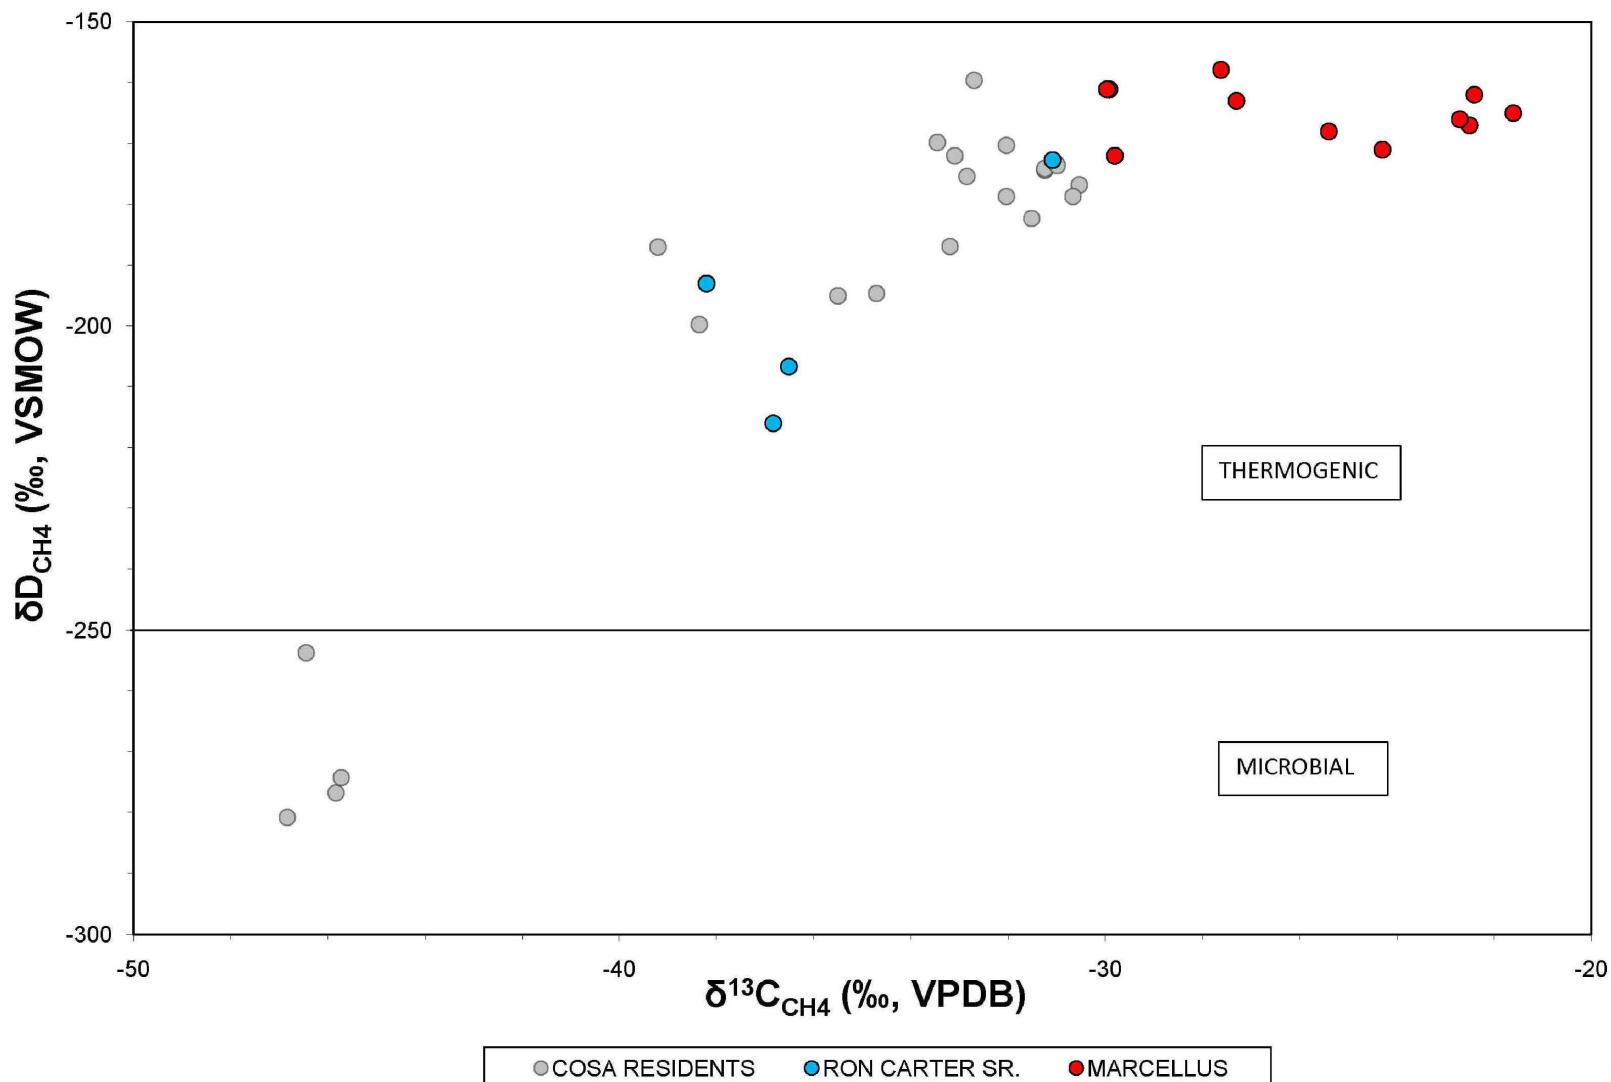
## Carter, Ron Sr. and Jean – Isotopes

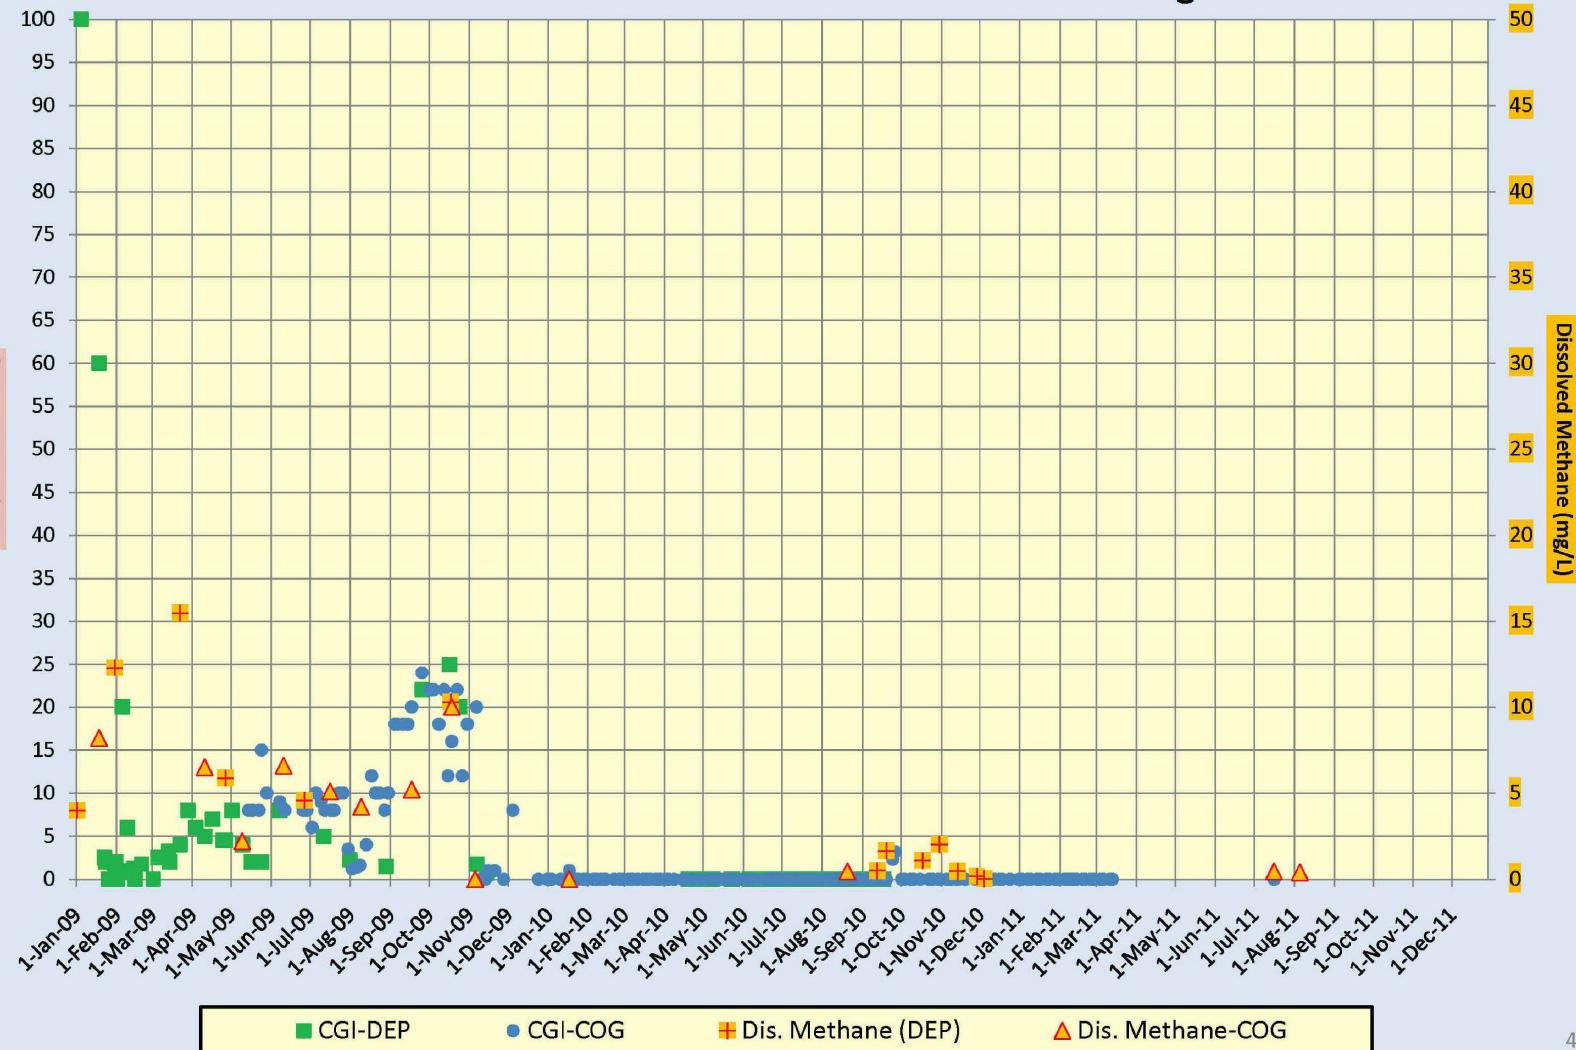
## Fiorentino – CGI and Dissolved Methane Graphs

Fiorentino - CGI and Dissolved Methane Readings

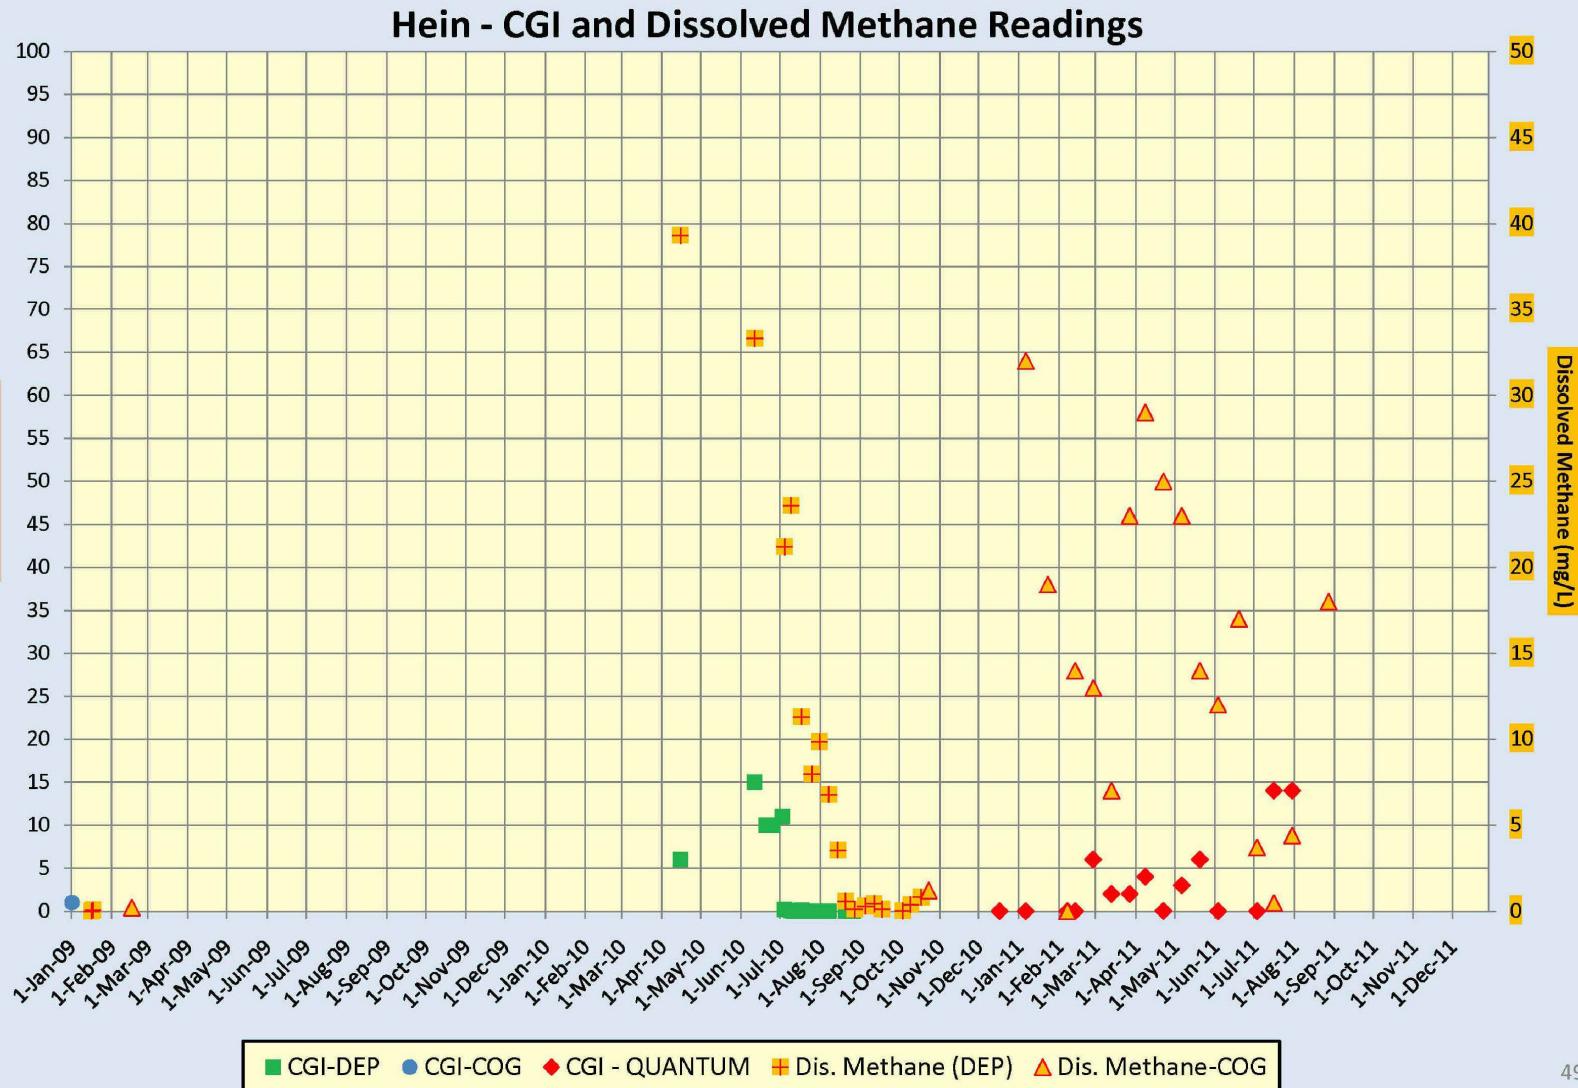
## Hein – CGI and Dissolved Methane Graphs

<b>Water Well - Owner</b>	Frederick and Jessica Hein
<b>Exceed Primary:</b>	None
<b>Exceed Secondary:</b>	Manganese
<b>Dissolved Gas:</b>	Most Recent Result = 18 mg/L (08/31/11)
Before Treatment:	17 mg/L (06/23/11)
After Treatment:	0.28 mg/L (06/23/11) System installed June 2011.
<b>Gas Wells ≤ 1000':</b>	Baker 1V - P&A Baker 3H
<b>Gas Wells 1000' - 2500':</b>	Gesford 2V Gesford 7H Gesford 5H Gesford 1V
<b>Plan Forward:</b>	Continue to monitor as per CO&SA.
<b>Comments:</b>	Received escrow funds. Installed treatment system. Not primary residence.

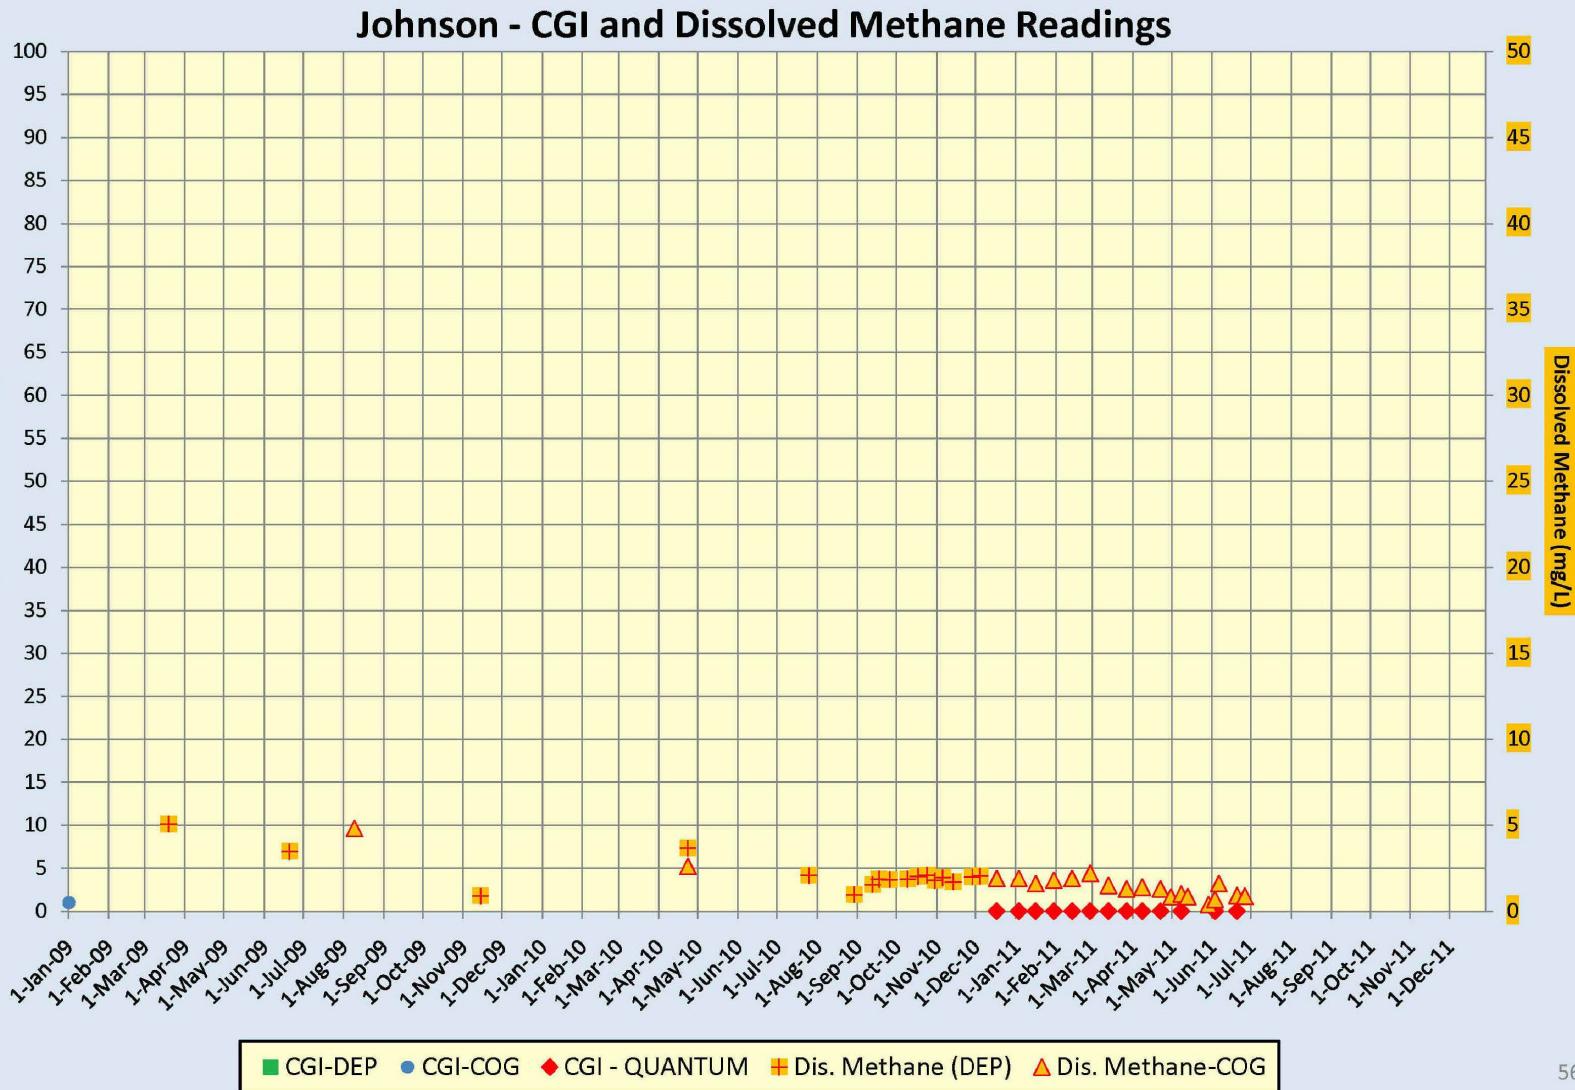
## Johnson – CGI and Dissolved Methane Graphs

<b>Water Well - Owner</b>	Michael and Suzanne Johnson	
<b>Exceed Primary:</b>	None	
<b>Exceed Secondary:</b>	Aluminum Iron	
<b>Dissolved Gas:</b>	Most Recent Result = 0.880 mg/L (06/30/11) Before Treatment: 1.6 mg/L (06/10/11) After Treatment: 0.035 mg/L (06/10/11) System installed in May 2011. No methane above 7 mg/L in data history.	
<b>Gas Wells ≤ 1000':</b>	Lewis 2V	
<b>Gas Wells 1000' - 2500':</b>	Costello 2V Ely 2V Ely 4V Ely 6H	Lewis 1V Costello 1V
<b>Plan Forward:</b>	Continue to monitor as per CO&SA.	
<b>Comments:</b>	Received escrow funds. Installed treatment system. Receiving bottled and bulk water. High iron bacteria and total suspended solids (TSS) => the Johnson's shock chlorinated their well. Cabot to verify corrective action through analytical testing.
